# **SOUTH CAROLINA ABANDONED BUILDINGS REVITALIZATION ACT**

## **ABANDONMENT EVIDENCE & SUPPORTING DOCUMENTATION**

| <b>Project Address:</b> | 753, 755, 757, 759 S. Washington Avenue,<br>Greenville, SC 29611 |
| <b>Date of Document:</b> | June 2026 |

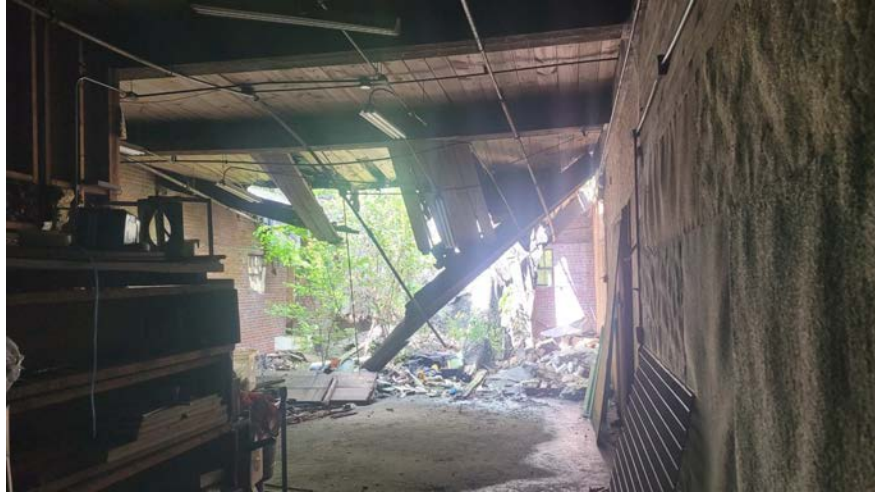
The photograph depicts a substantial roof collapse and vegetation growing within the building footprint. The extent of structural deterioration and natural encroachment demonstrates that the property has remained vacant and unmaintained for a prolonged period.

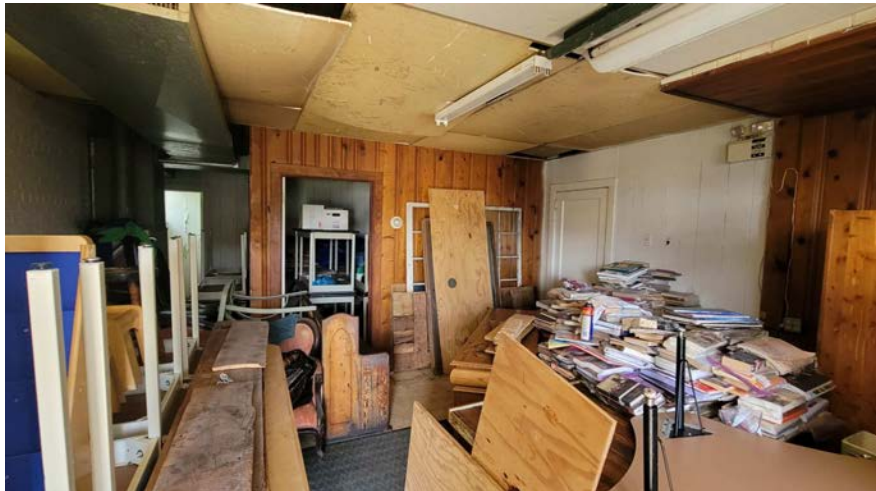
The photograph depicts an interior space containing accumulated debris and abandoned materials. The lack of active use, housekeeping, or maintenance is consistent with a building that has been vacant and unoccupied for an extended period.

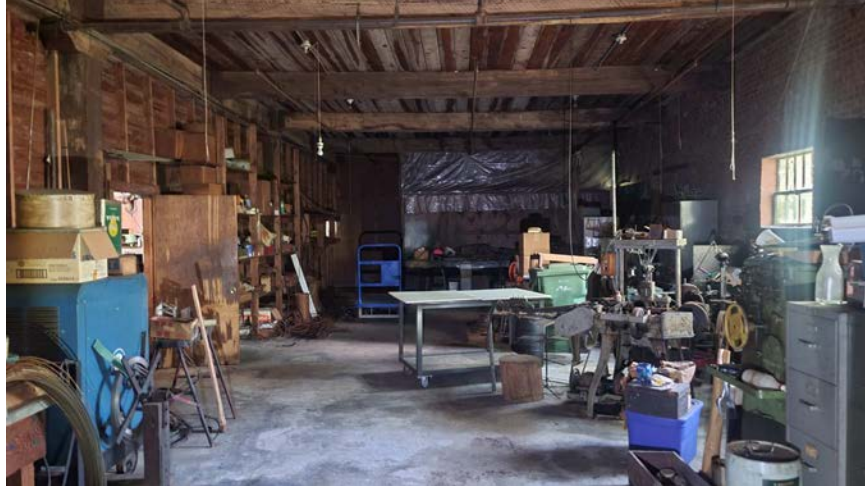
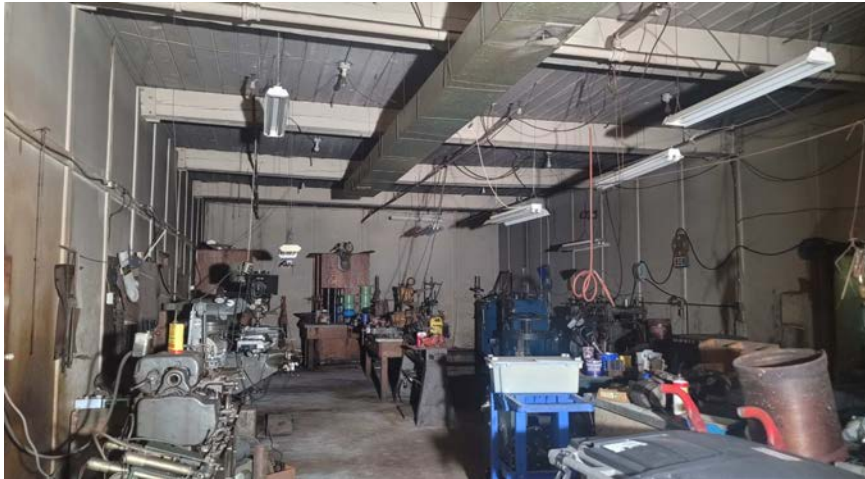
The photographs above depict exposed electrical wiring hanging from the ceiling and building contents that appear to have remained undisturbed for an extended period. These conditions are indicative of long-term vacancy, deferred maintenance, and abandonment of the property.

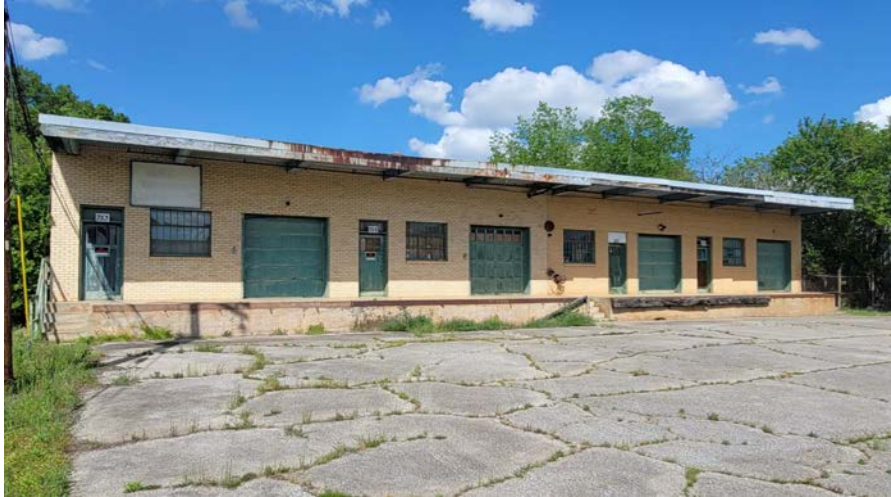
Pictured above: Photo of property from 2025

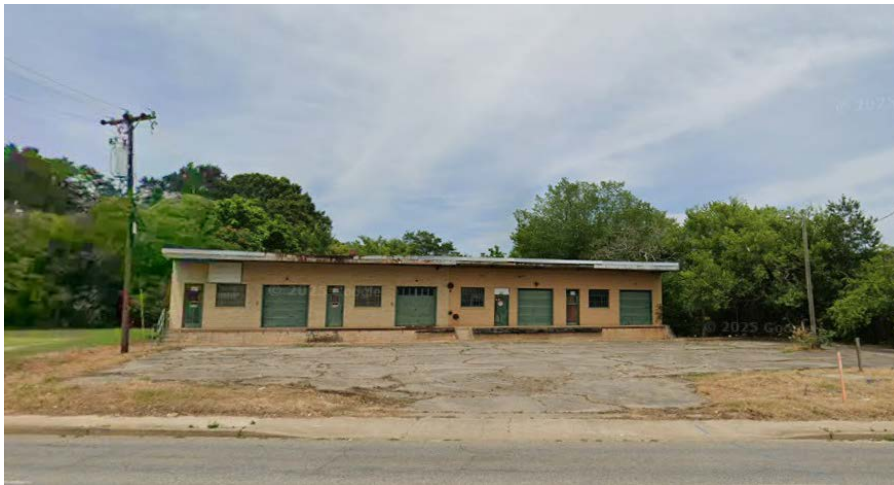
Pictured above: Google Map photo of property from June 2023

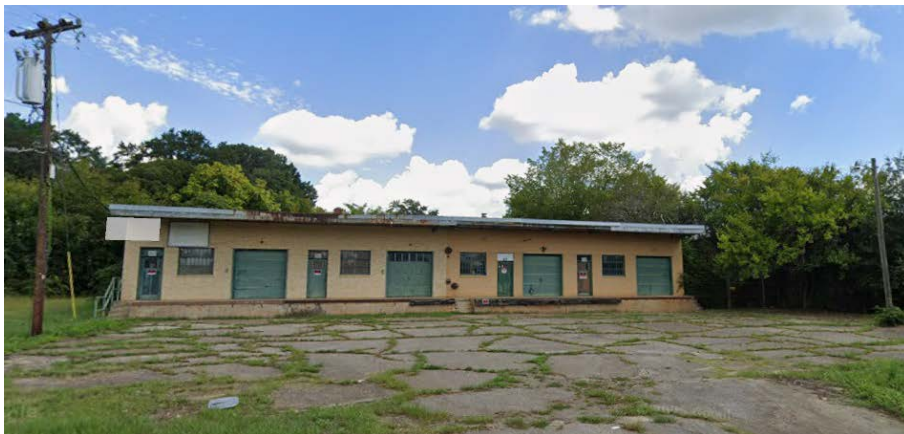
Pictured above: Google Map photo of property from September 2022

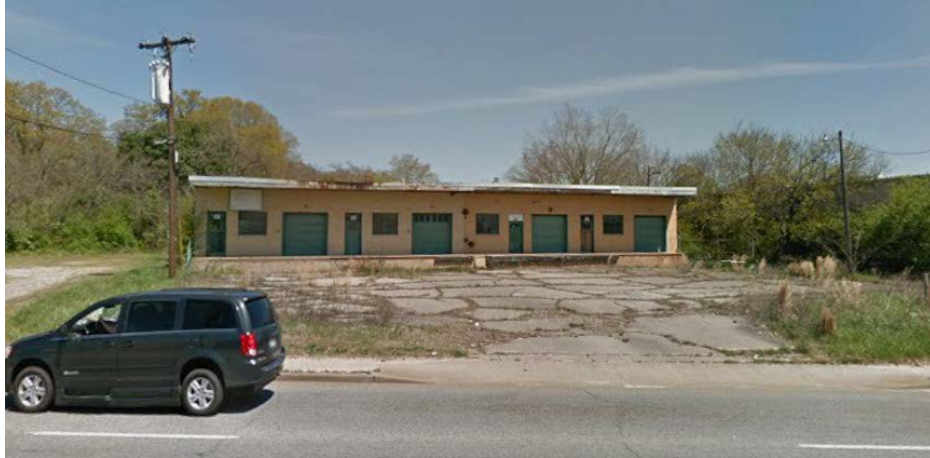
Pictured above: Google Map photo of property from April 2019

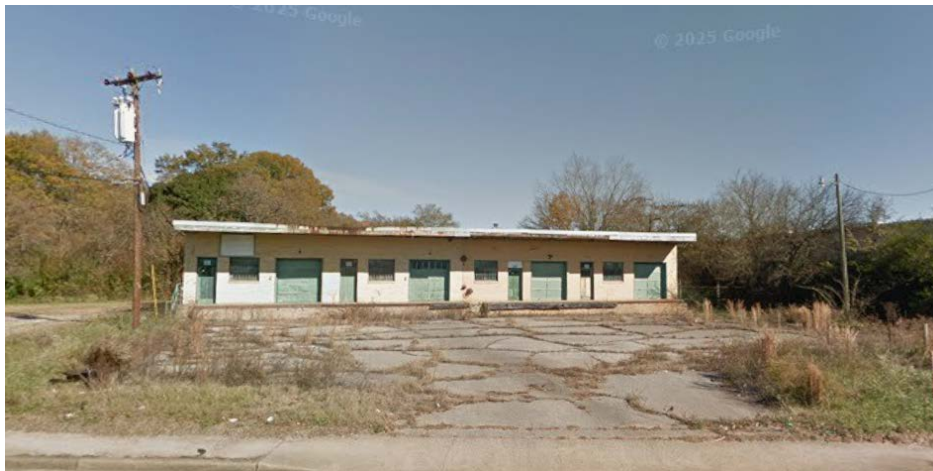
Pictured above: Google Map photo of property from November 2018

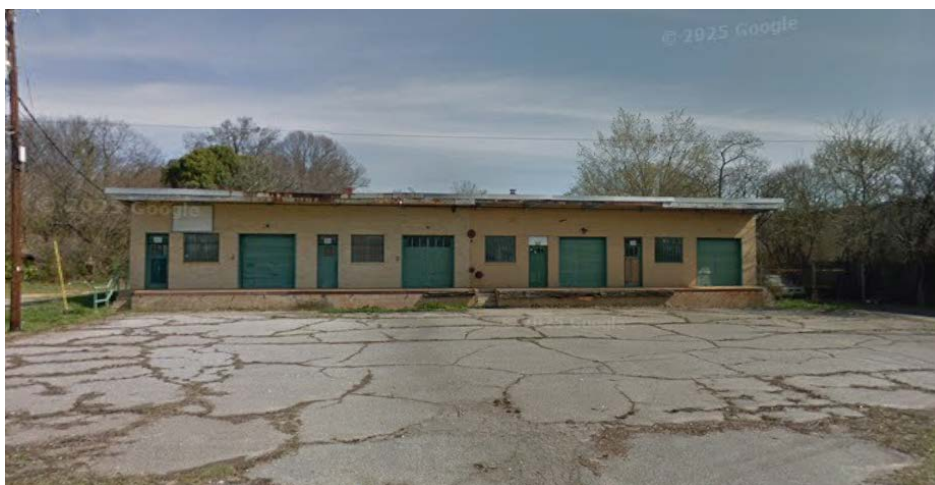
Pictured above: Google Map photo of property from March 2017

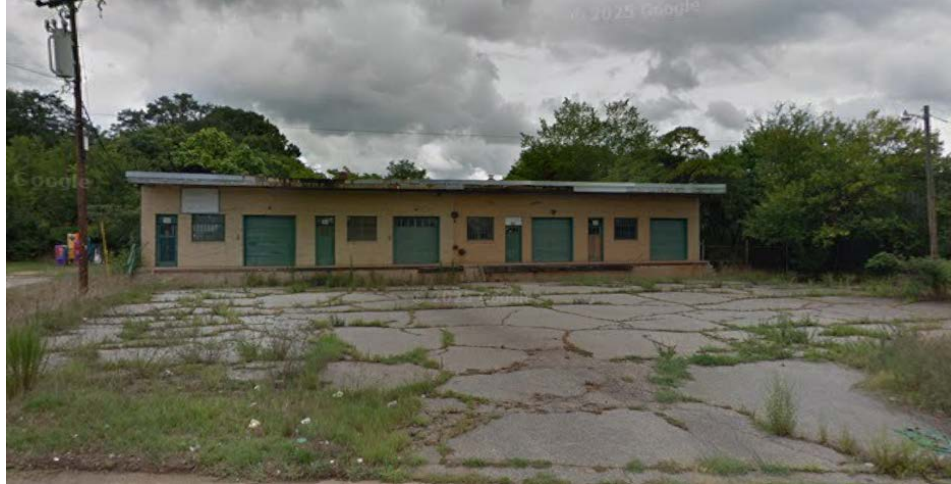
Pictured above: Google Map photo of property from August 2016
